# Red River Waterway, Lock and Dam 3

Report 2
Navigation Alignment Conditions
Hydraulic Model Investigation

Report 2 of a series

Prepared for U.S. Army Engineer District, Vicksburg Vicksburg, MS 39180-3435

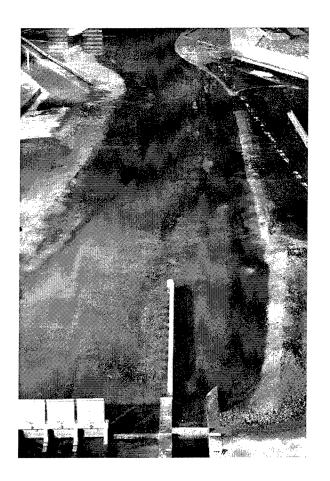
Photo 8. Plan I, looking upstream

The Vicksburg District made the decision to develop a plan that would not require the removal of revetment 143.0L or require a setback of the levee in that area. Plan I was the channel realignment selected to meet those criteria. The alignment of the navigation channel near the upstream end of the model was similar to Plan D, and the channel approaching the lock was the same as Plans G-3 and G-4. The principal features of the plan were as follows (Figure 25 and Photo 8):

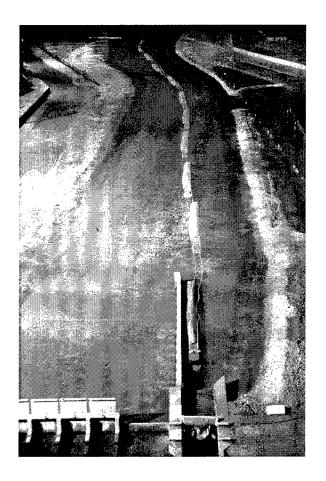
Photo 18. Plan I-1, looking upstream, discharge 80,000 cfs, showing path of upbound tow
